**TIMBER VS. COMPOSITE/PLASTIC PILE FENDER SYSTEMS IN PEARL HARBOR  
MAINTENANCE COST COMPARISON**

**A PLAN B PAPER SUBMITTED TO THE DEPARTMENT OF OCEAN ENGINEERING  
OF THE UNIVERSITY OF HAWAII IN PARTIAL FULFILLMENT OF THE  
REQUIREMENTS FOR THE DEGREE OF**

**OCEAN ENGINEERING**

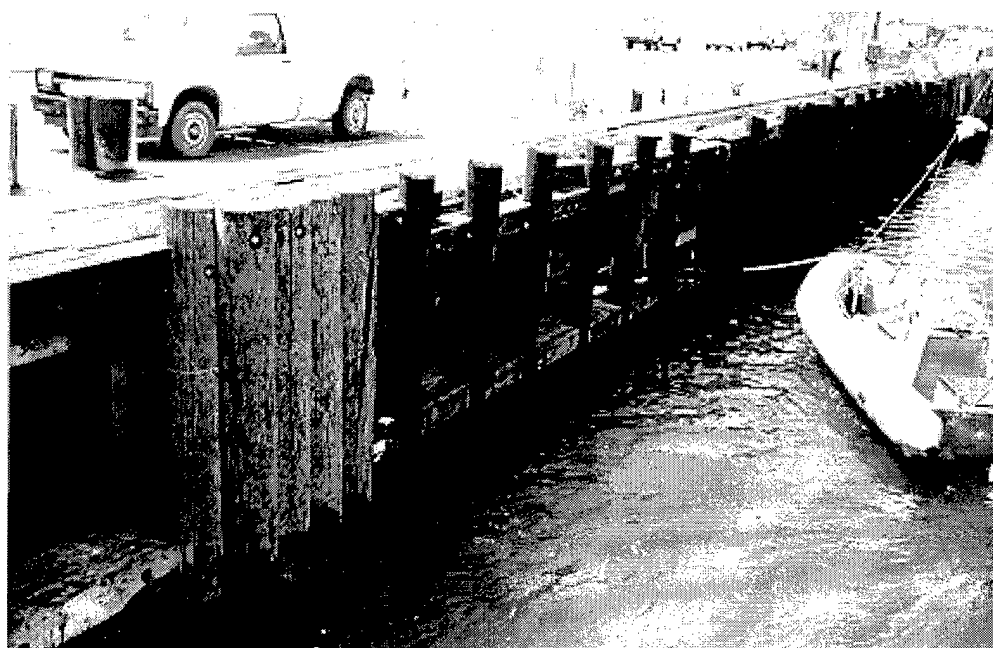
Figure 2. Typical Surface Vessel Timber Fender System - Pearl Harbor

Some typical Pearl Harbor timber fender systems are shown in Figures 3 and 4. From this survey, it was evident that there are basically three configurations of timber fender systems presently employed in Pearl Harbor. These configurations are specified in Table 1. The first timber fender configuration is a driven pile system. This configuration slightly varies at different locations in Pearl Harbor basically by the placement and/or number of piles, walers, chocks and blocks as discussed in the military handbook (MIL-HBK-1025/1, 1994). The second configuration is a "hanging pile" design which ties the timber pile system to two points on the shore facility, one at the bull rail and the other

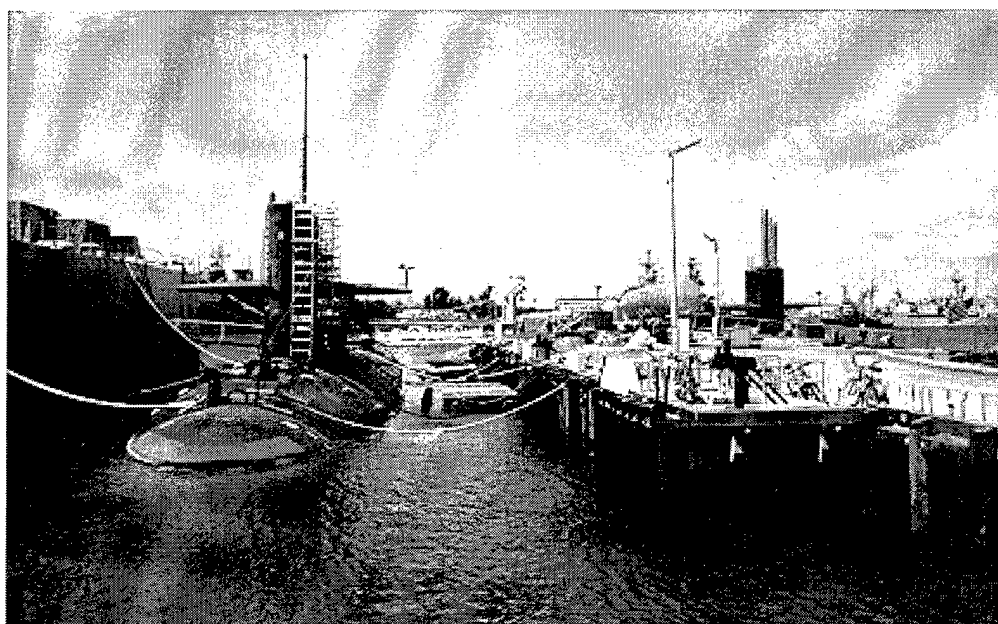
Figure 3. Typical Submarine Timber Fender System - Pearl Harbor
